Fixed Prosthesis on Two Implants from Different Manufacturing Companies Case Report

Abstract: The following is a clinical case of a screw-retained prosthesis on two implants with different designs and manufacturers. A 73-year-old man visited the dentist in January 2023 to rehabilitate the edentulous right area of the mandible. In December 2018 another dentist placed implants (Biohorizons, Madrid, Spain) in positions 45 and 46 with a metal-porcelain bridge over both. In 2022 he lost implant 45 (Biohorizons tapered internal 3.8 x 9) and with it also the bridge, although he still had implant 46 (Biohorizons tapered short 4.6 x 7.5). On the day of surgery, a simple opening flap was performed and drills were used sequentially until a 4 x 8 mm Galimplant IPX implant (Sarria, Spain) was placed in position 45. After a period of four months, the impression abutments of implants 46 and 45 were attached with dental floss and flowable composite, and an open-tray impression was taken. One week later, the screwed metal-porcelain fixed prosthesis was placed on both implants. It is difficult to find bibliographic information about fixed prostheses on implants manufactured by different companies a

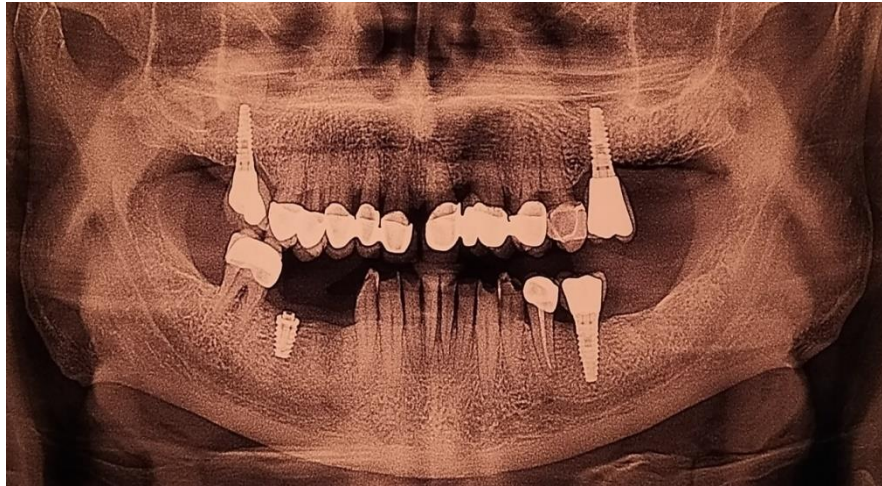
Fig. 1: Orthopantomography before treatment

porcelain bridge over both. In 2022 he lost implant 45 (Biohorizons tapered internal 3.8 x 9) and with it also the bridge, although he still had implant 46 (Biohorizons tapered short 4.6 x 7.5). For this reason, an orthopantomography was requested (fig. 1).

In that image, the existence of implant 46 was seen. Then, it was thought to rehabilitate the area by placing a new implant 45, with a delayed technique in the placement of the fixed prosthesis. A healing abutment was placed on implant 46. The

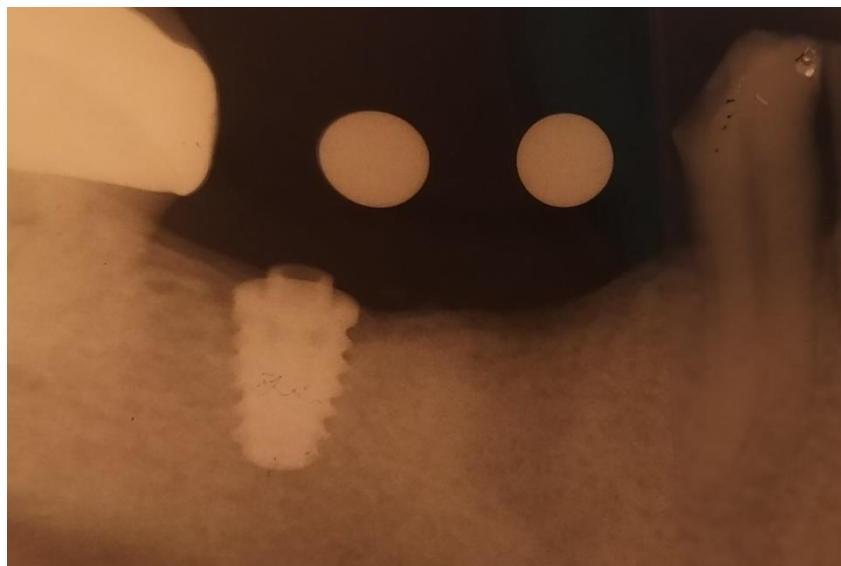
Fig. 2: Periapical radiograph with a 4 mm reference metal ball

diagnosis was completed by taking several periapical radiographs of the area from different angles, with 4-mm-diameter metal balls as references (fig. 2).

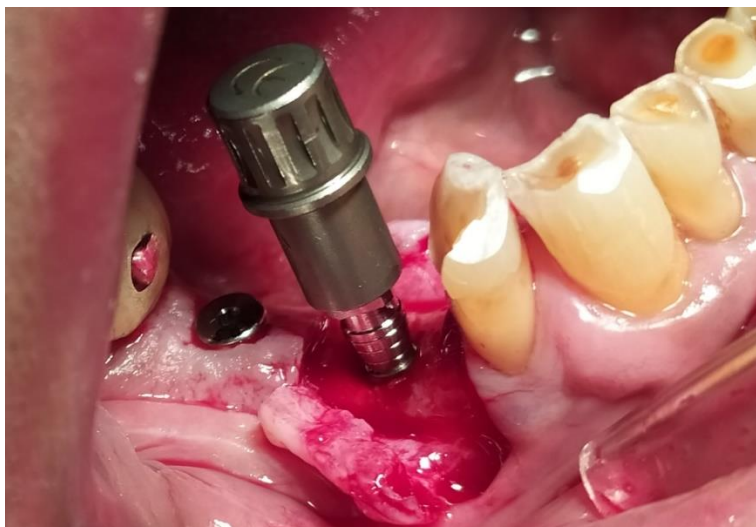
Fig.3: Galimplant IPX 4 x 8 mm implant placement in position 45

was advised for prevention. On the day of surgery, a simple opening flap was performed and drills were used sequentially until a 4 x 8 mm Galimplant IPX implant (Sarria, Spain) was placed in position 45 (fig. 3).

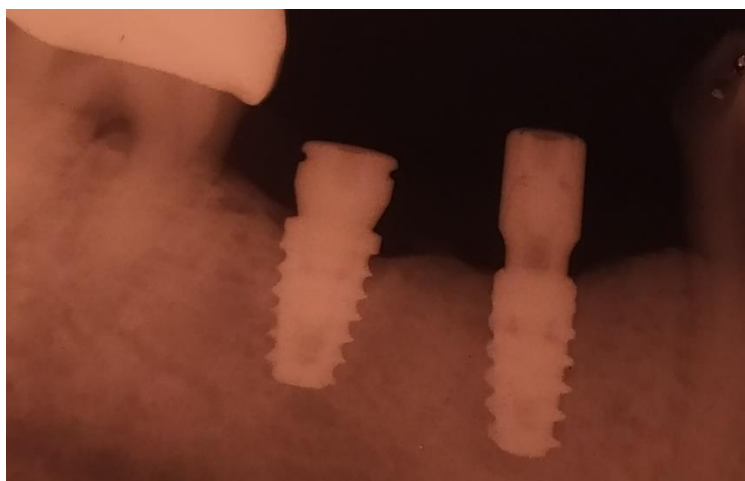
Fig.4: Periapical radiograph of the implants 46 and 45

Bone drilling was carried out correctly in width and depth, achieving good primary stability (fig.4).

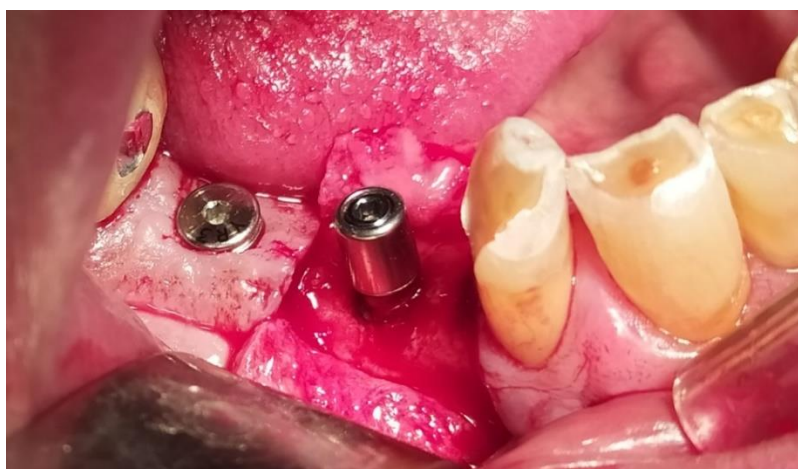
Fig.5. Placement of the transepithelial abutment on the implant 45

At that time, a transepithelial abutment (2 mm high rotational aesthetic straight multiposition

abutment, Galimplant. Sarria. Spain) was placed on implant 45 (fig. 5).

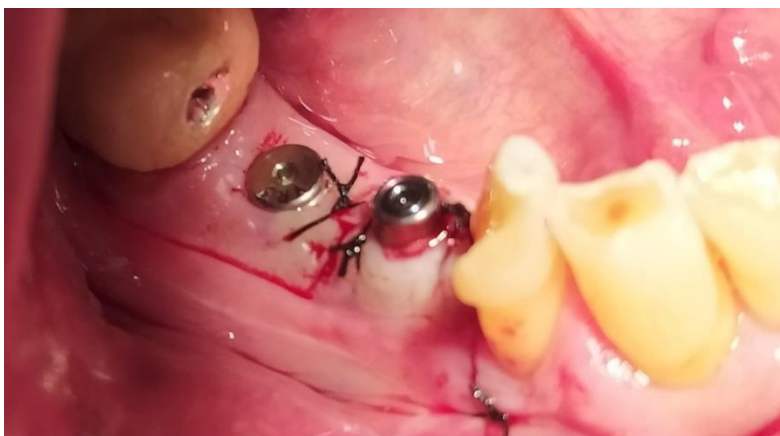
Fig.6: Surgical image with five 4/0 silk stitches

It was closed with silk sutures non adsorbable 4/0 (fig.6). After surgery, he was advised to take ibuprofen 400mg every 8 hours if he had inflammation or pain. The next day the patient was

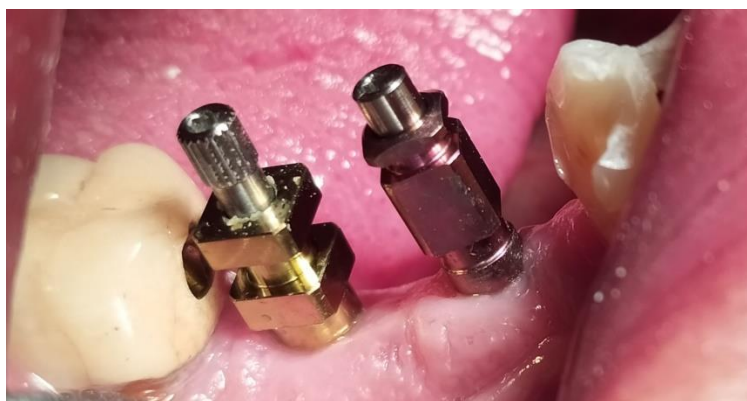
Fig.7: Placement of impression abutments on implants of different brands

After four months, the impression abutments of implants 46 and 45 were attached with

dental floss and flowable composite, and an open-tray impression was taken (figs.7, 8, and 9).

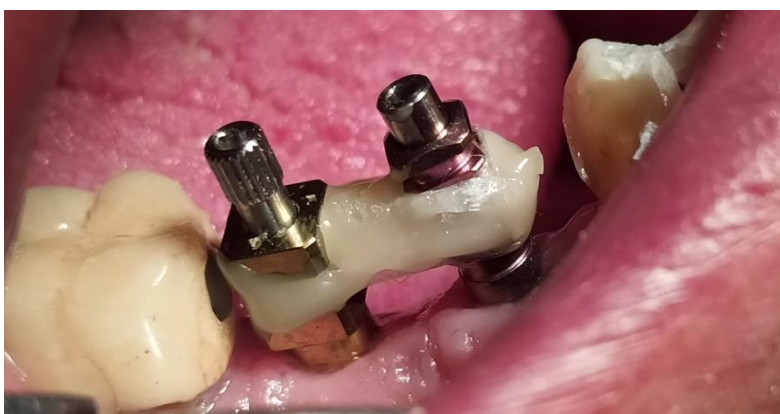
Fig 8: Union of both impression abutments with dental floss and flowable composite

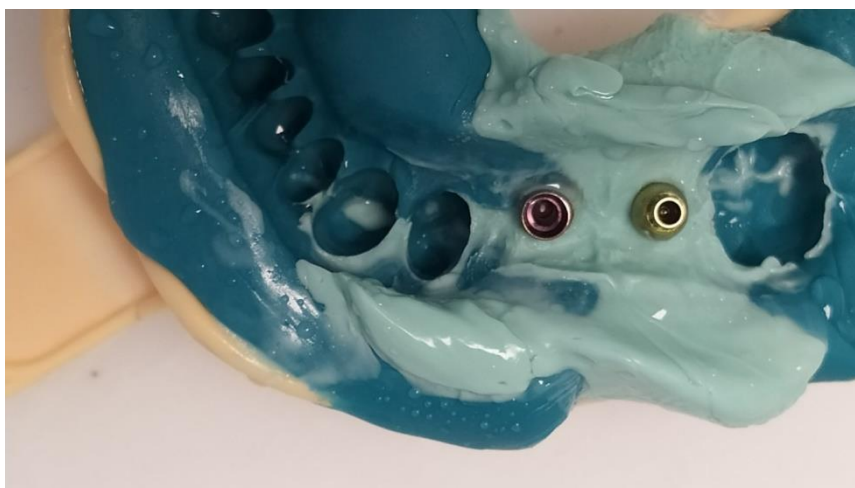
Fig 9: Impression image with open tray

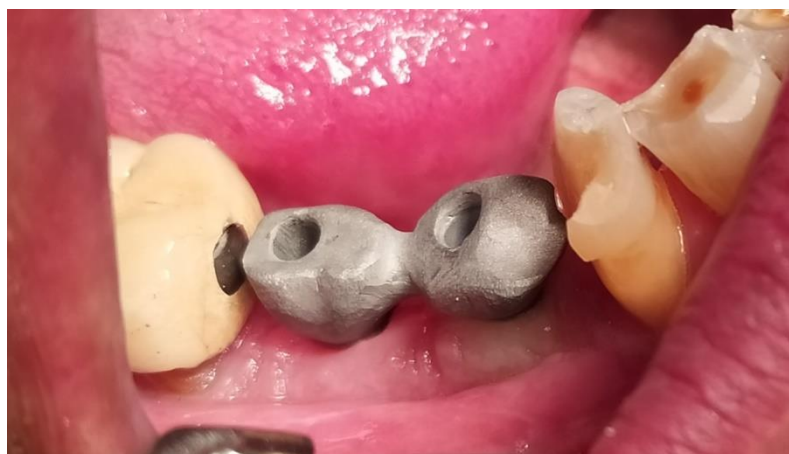
Fig.10: Metal prosthesis on both implants

When the metal prosthesis was tried on, it was found that the fits were excellent (Fig 10). One week later, the screwed metal-porcelain fixed

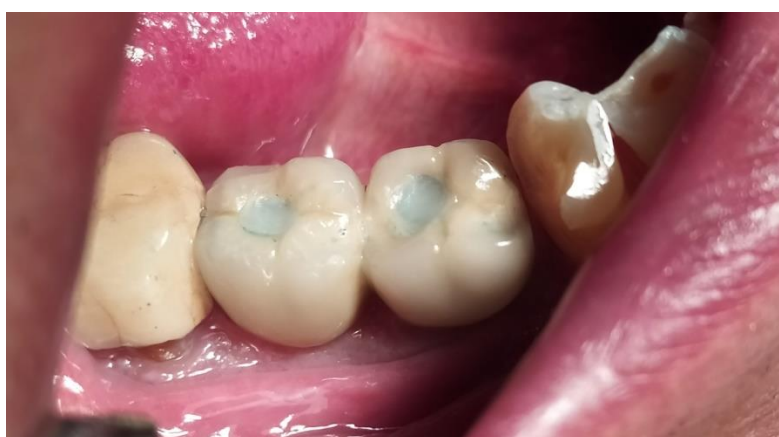
Fig.11: Final placement of the metal-porcelain bridge

prosthesis was placed on both implants, closing the gaps with a Teflon and composite insulator (Herculite XRV, Kerr, USA) (Fig 11).
